JAGUAR MINING ACCESSES NEW HIGH-GRADE MINERALIZED ZONE IN BA-TORRE STRUCTURE DEVELOPMENT INTERSECTS MINERALIZATION ALONG CONTINUOUS STRIKE OF >130M WITH BEST INDIVIDUAL CHANNELS GRADING

Toronto, February 28, 2024 – Jaguar Mining Inc. ("Jaguar" or the "Company") (TSX: JAG, OTCQX: JAGGF) is pleased to announce that exploration access development on the level 15.2 elevation in the BA-Torre structure of its Pilar mine in Brazil has intersected and confirmed extensive high-grade mineralization, previously intersected in exploration diamond drill holes announced in the first half of 2023. Jaguar believes that this area could positively affect the Pilar mine's future production capacity.

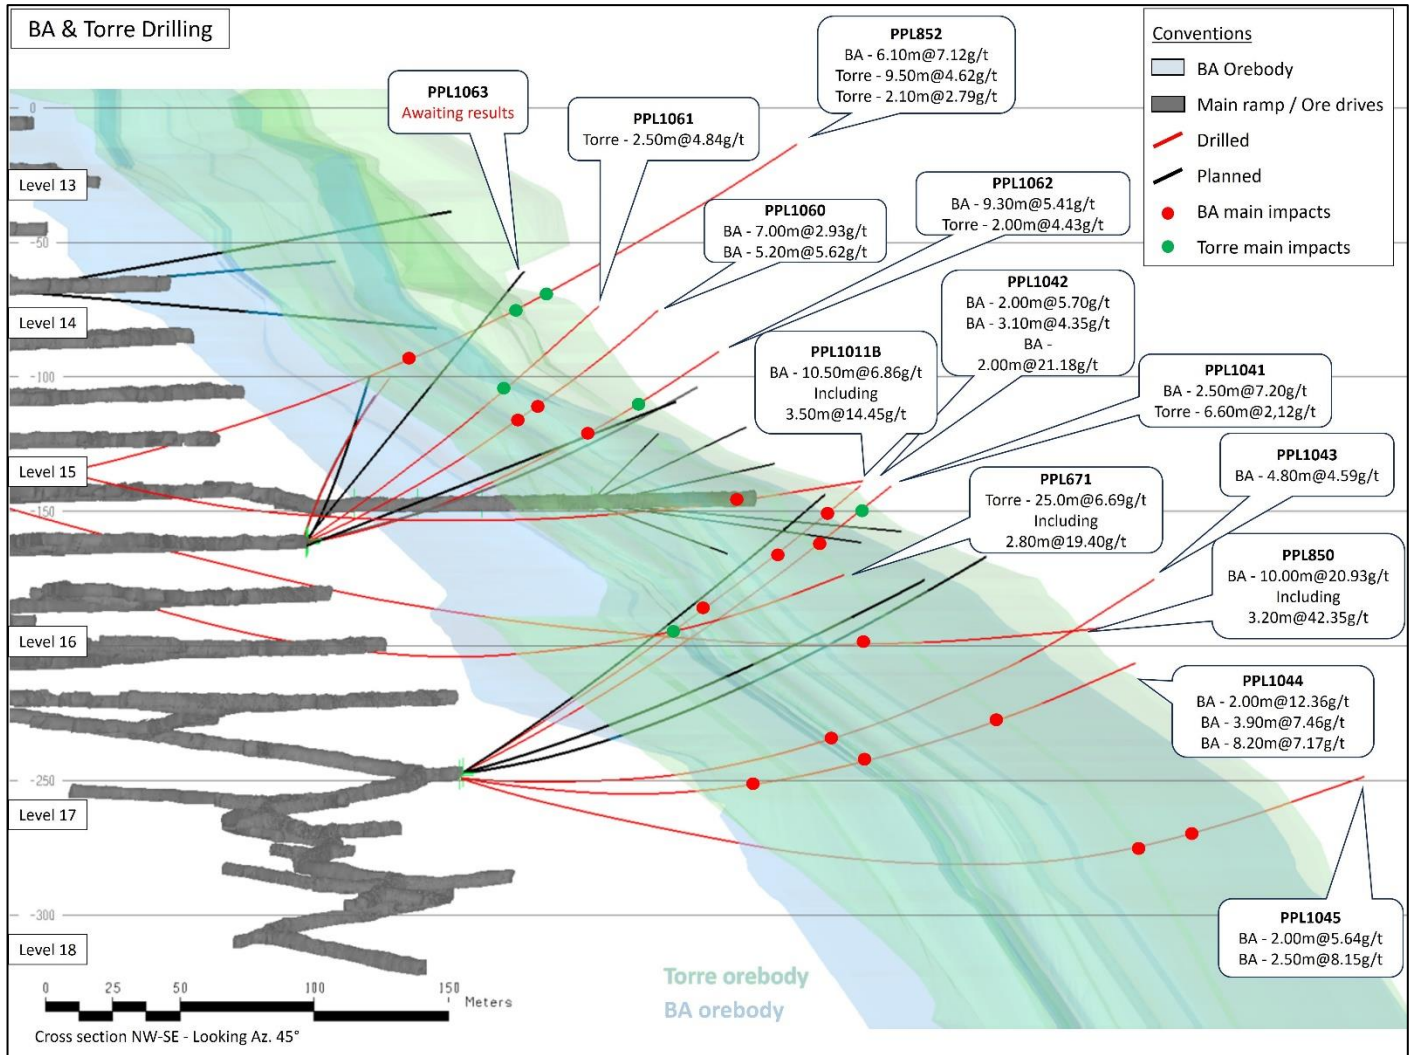
Figure 3 – Long sectional view showing the location of access development to evaluate the BA-Torre structure on level 15-2 and the best diamond drill mineralized intersections reported in this press release and previously in the press release dated February 21, 2023 (original holes in white-background boxes/recent and current holes shown with yellow-background boxes).

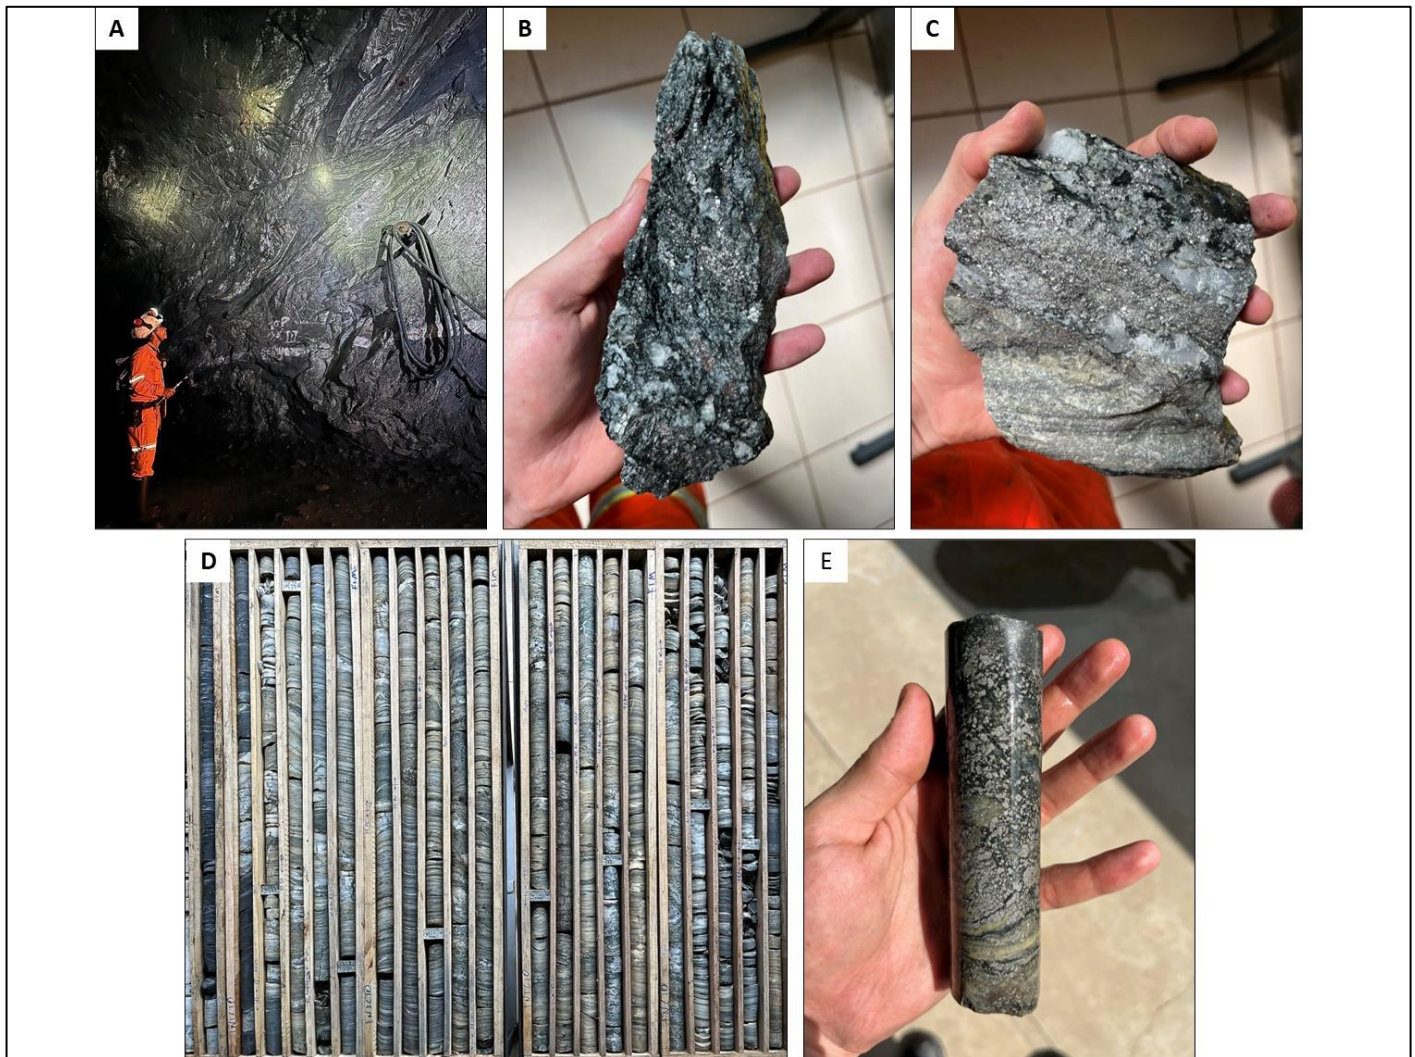
Figure 6 – Section of photographs from the access development in level 15.2 BA mineralized zone.

- A) Thin carbonaceous phyllite layer folded by shear strain, surrounded by carbonate facies BIF package.**
B) BA mineralization chip sample. Hydrothermalite composed of chlorite, arsenopyrite and quartz.
C) BA mineralization chip sample. Same as image B, showing the contact between the alteration zone and host BIF.
D) Main mineralized interval on PPL1062, one of the recent drill holes targeting the BA mineralization.
E) Coarse grains of arsenopyrite within altered BIF mineralization zone intersected in drillhole PPL1062.
