Jaguar Mining Reports Consistent Drilling Results at the BA Zone of the Pilar Gold Mine, Brazil, Demonstrating Down-plunge Continuity

- Technical update on exploration drilling & resource expansion strategy

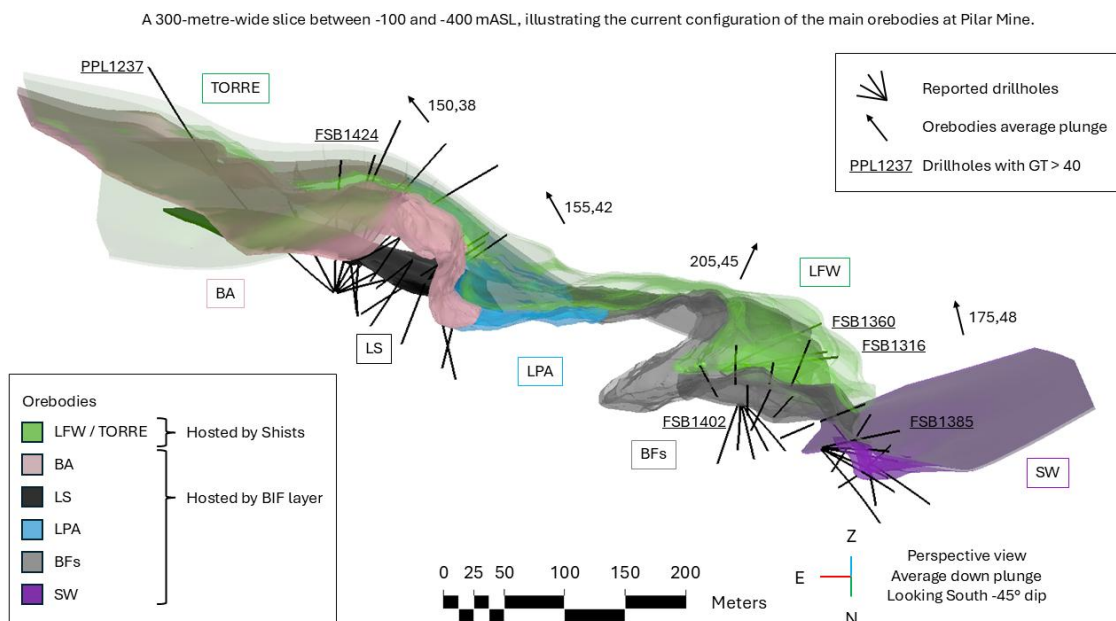
Figure 3: 3D Resource Model and Exploration Target. A spatial representation of the exploration target, showing how recent drilling is successfully intersecting the projected mineralized zones.
